# CLOSED LANDFILL SEMINAR LOSCOE AND CRANBOURNE CASE STUDIES

April 2013

Stephen Cambridge

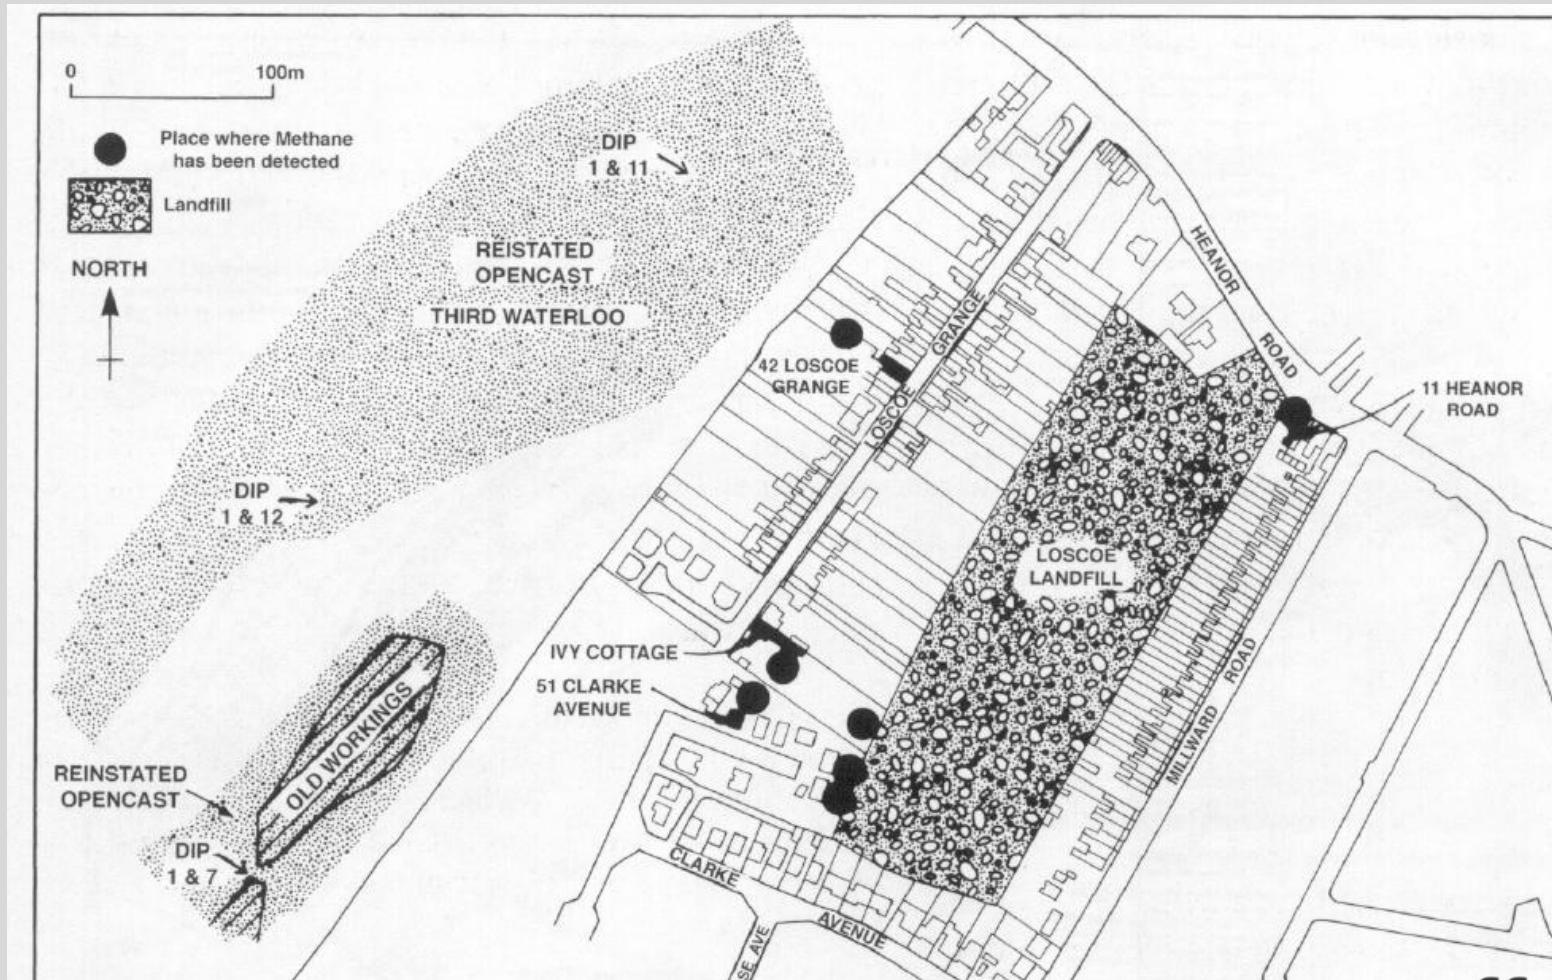
- Brickworks from mid 19<sup>th</sup> Century until the early 1970's with a clay pit 70m from the Clarke Ave houses which were built in the 1970's

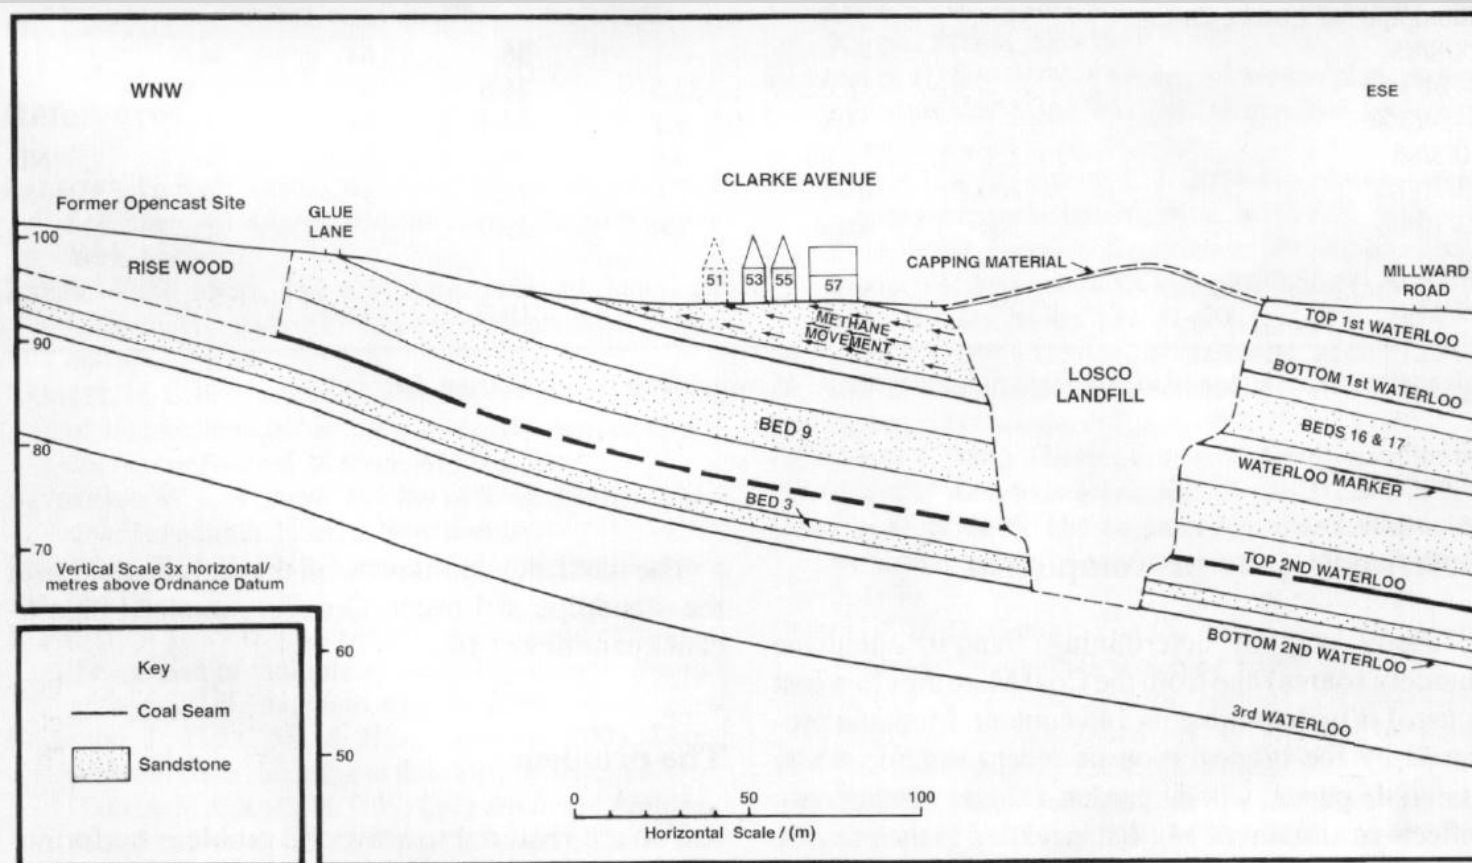
- The clay pit comprised an elliptical hole with three stepped quarry faces.
- In 1977 a licence was granted to tip a wide variety of wastes, including 50 tons per day of untreated domestic waste.

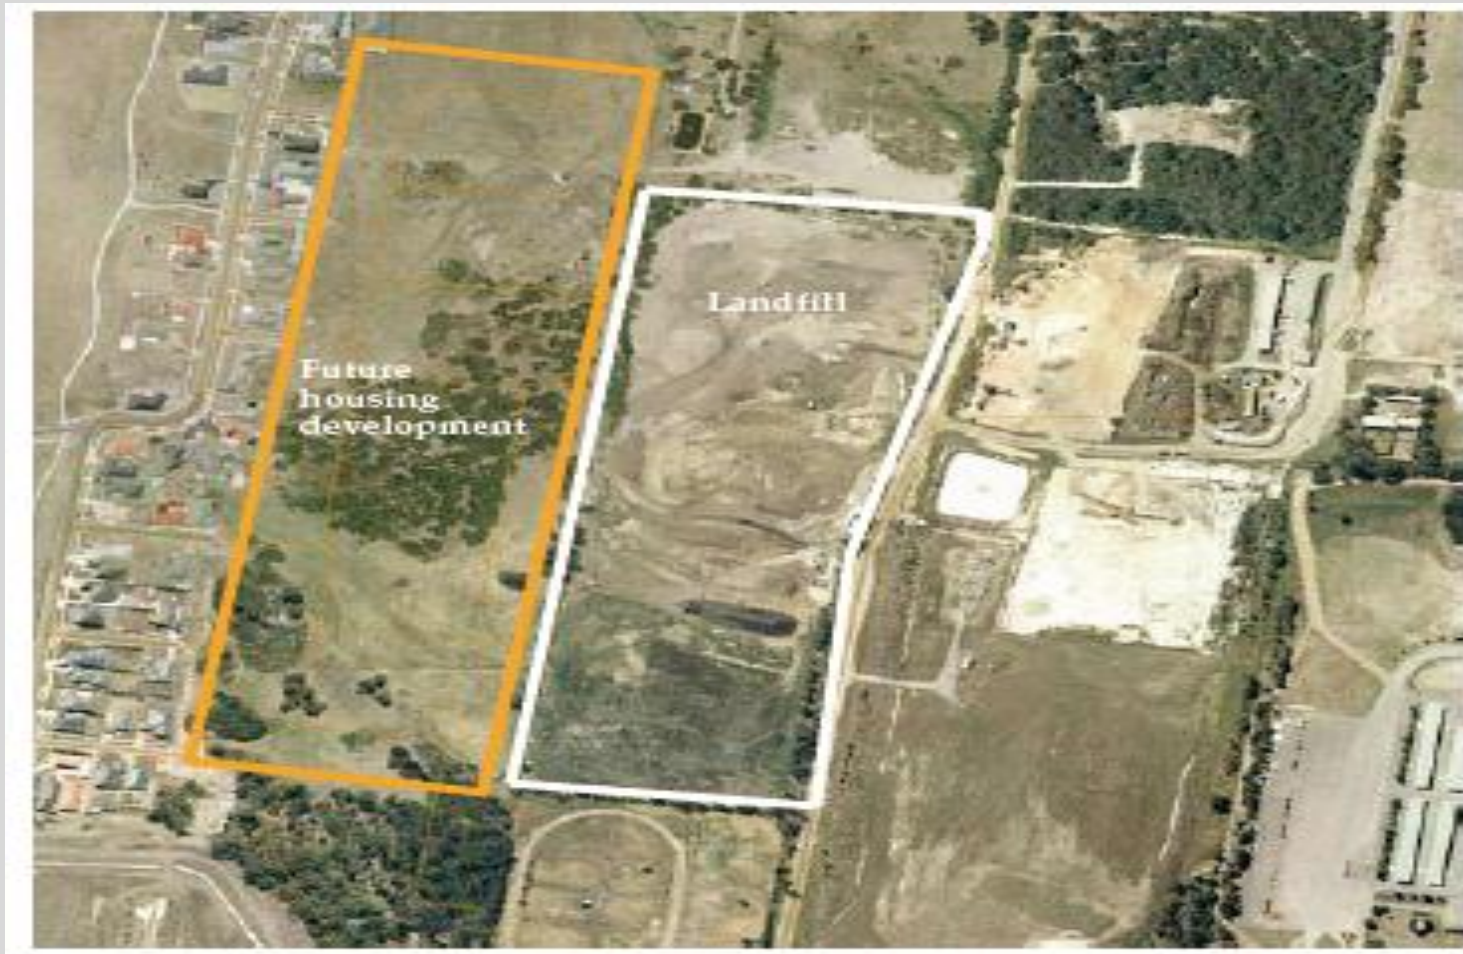
- Former domestic waste landfill (1996 to 2005)

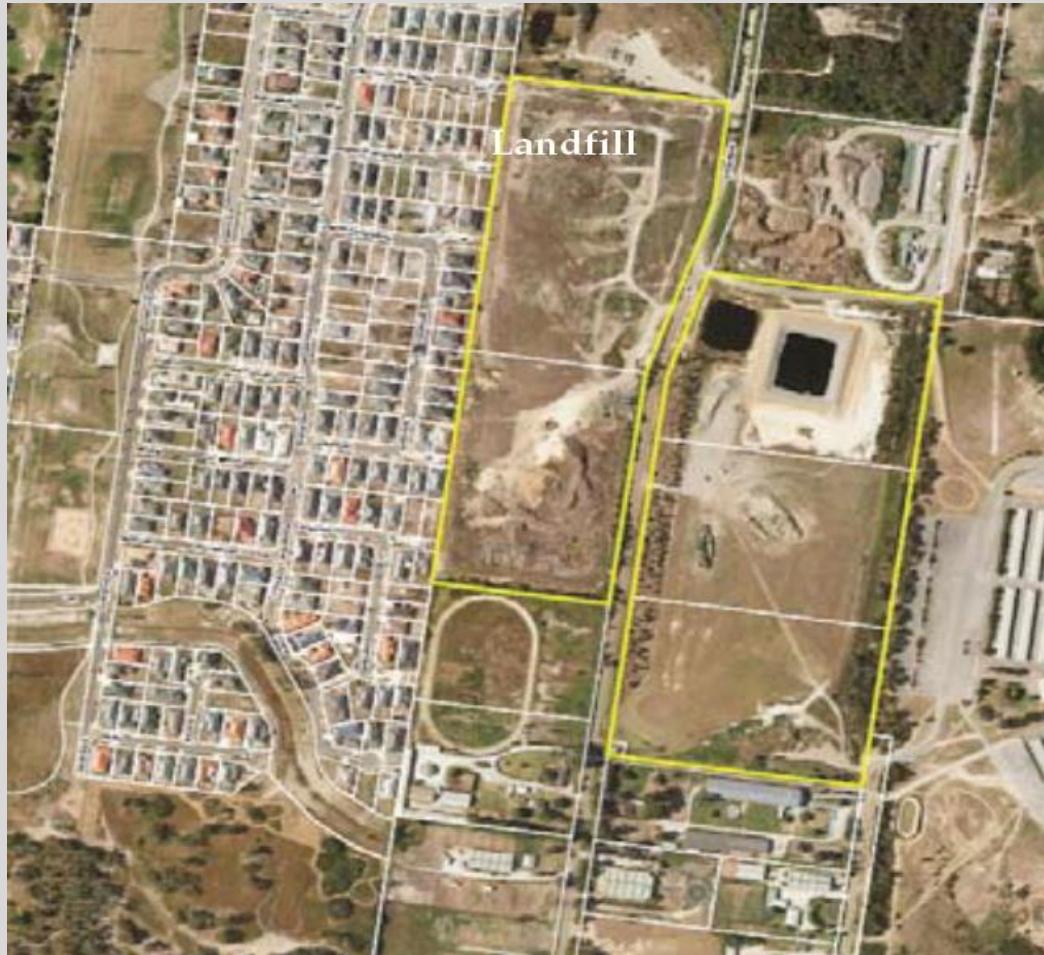
- Brookland Greens Estate development

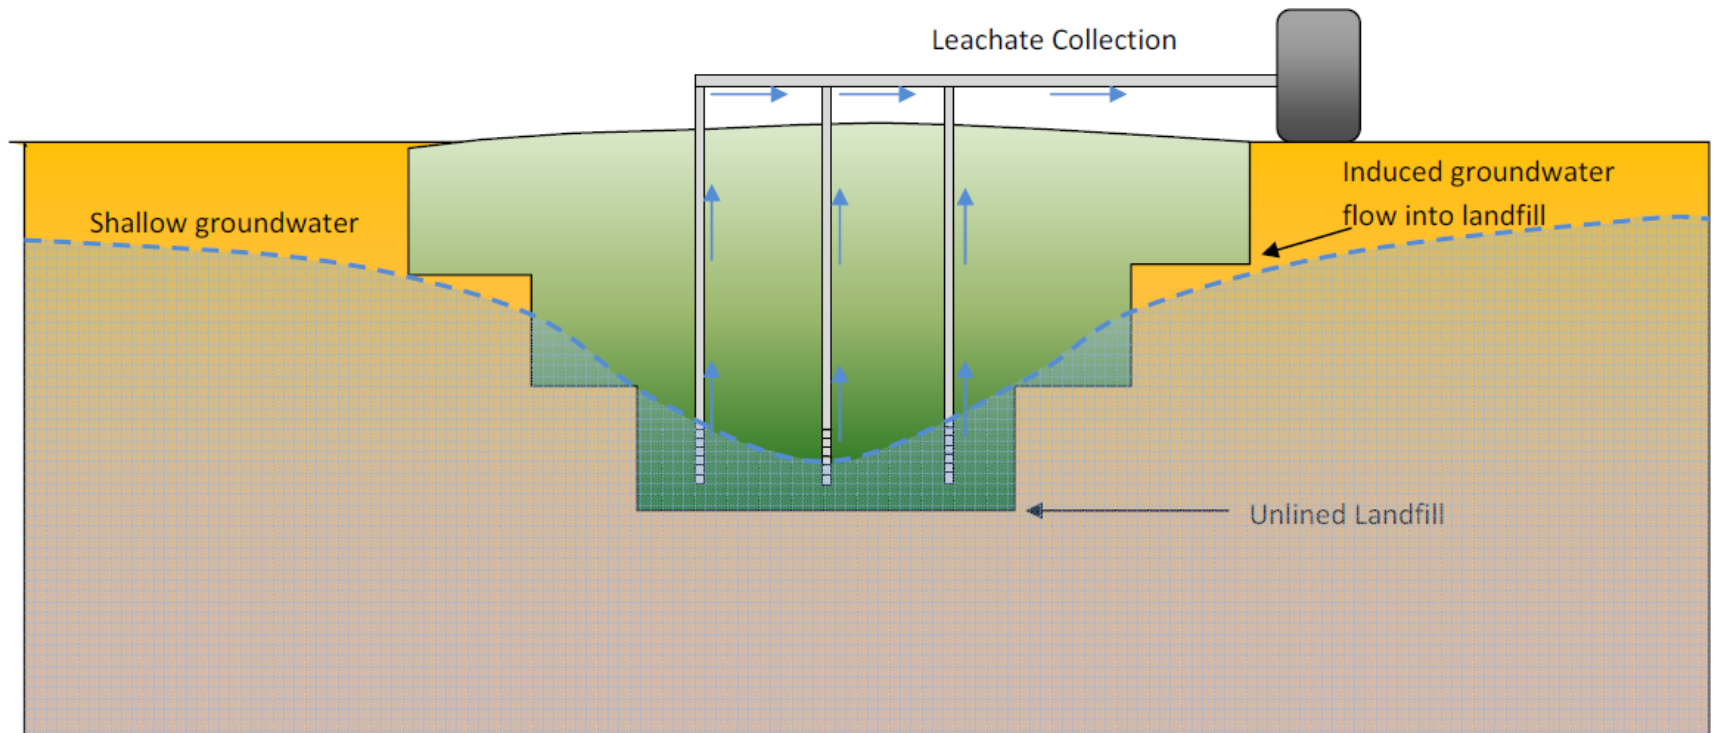
- Landfill was designed and constructed in early to mid 1990's

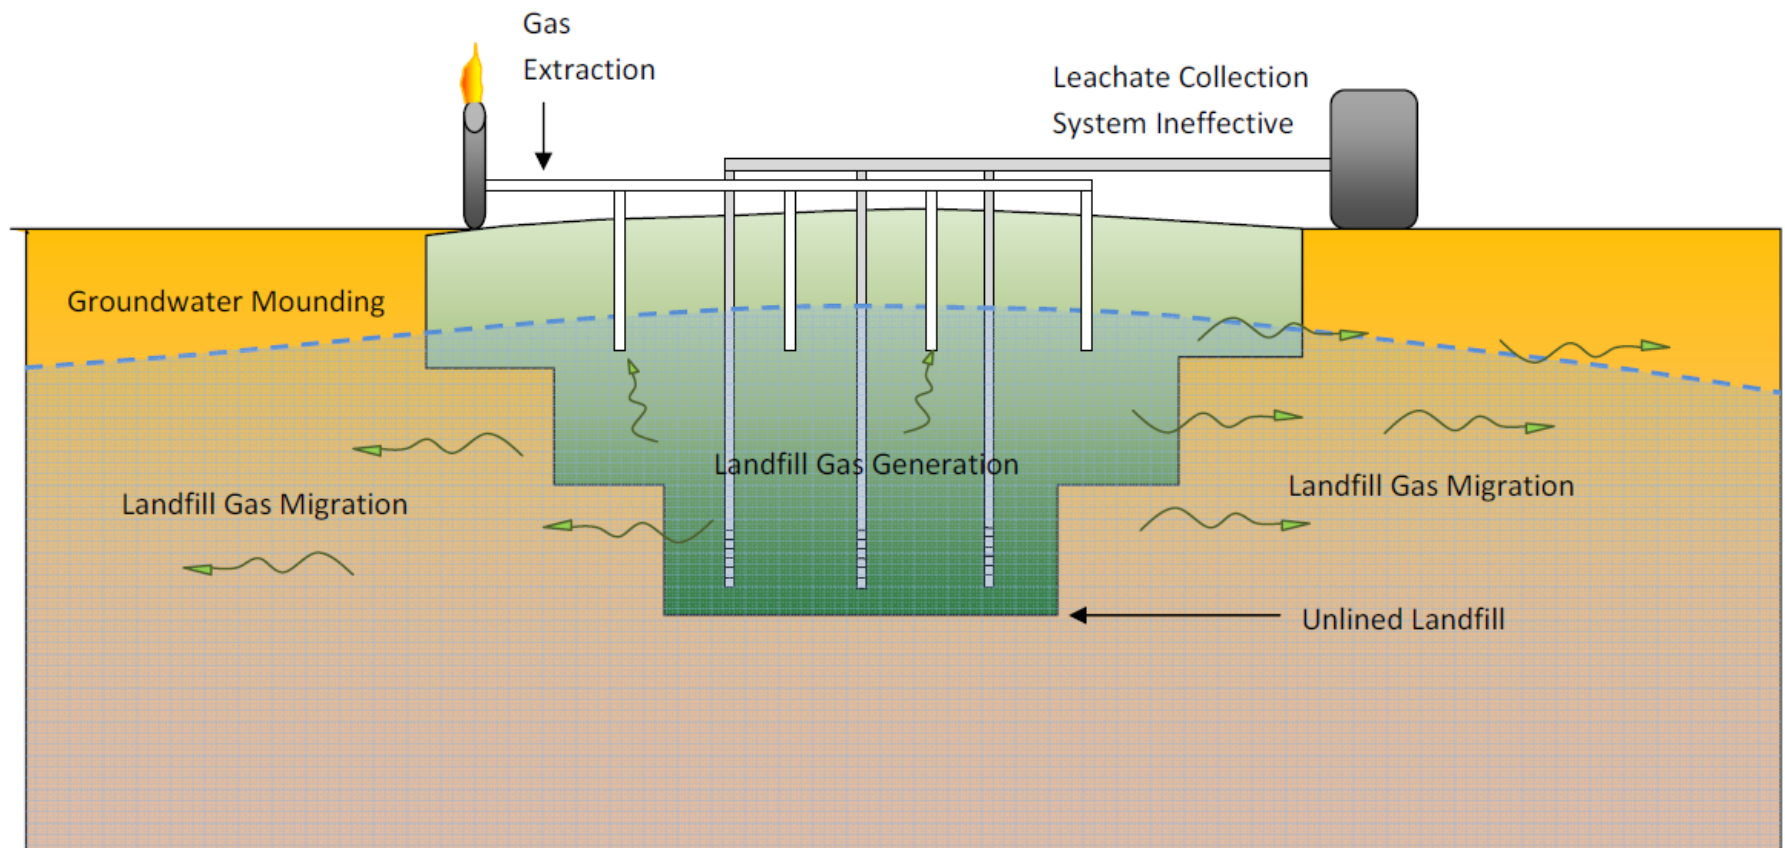
- Extraction system flooded, inhibiting effective gas removal and resulting in increase methane generation (concentration and volume).

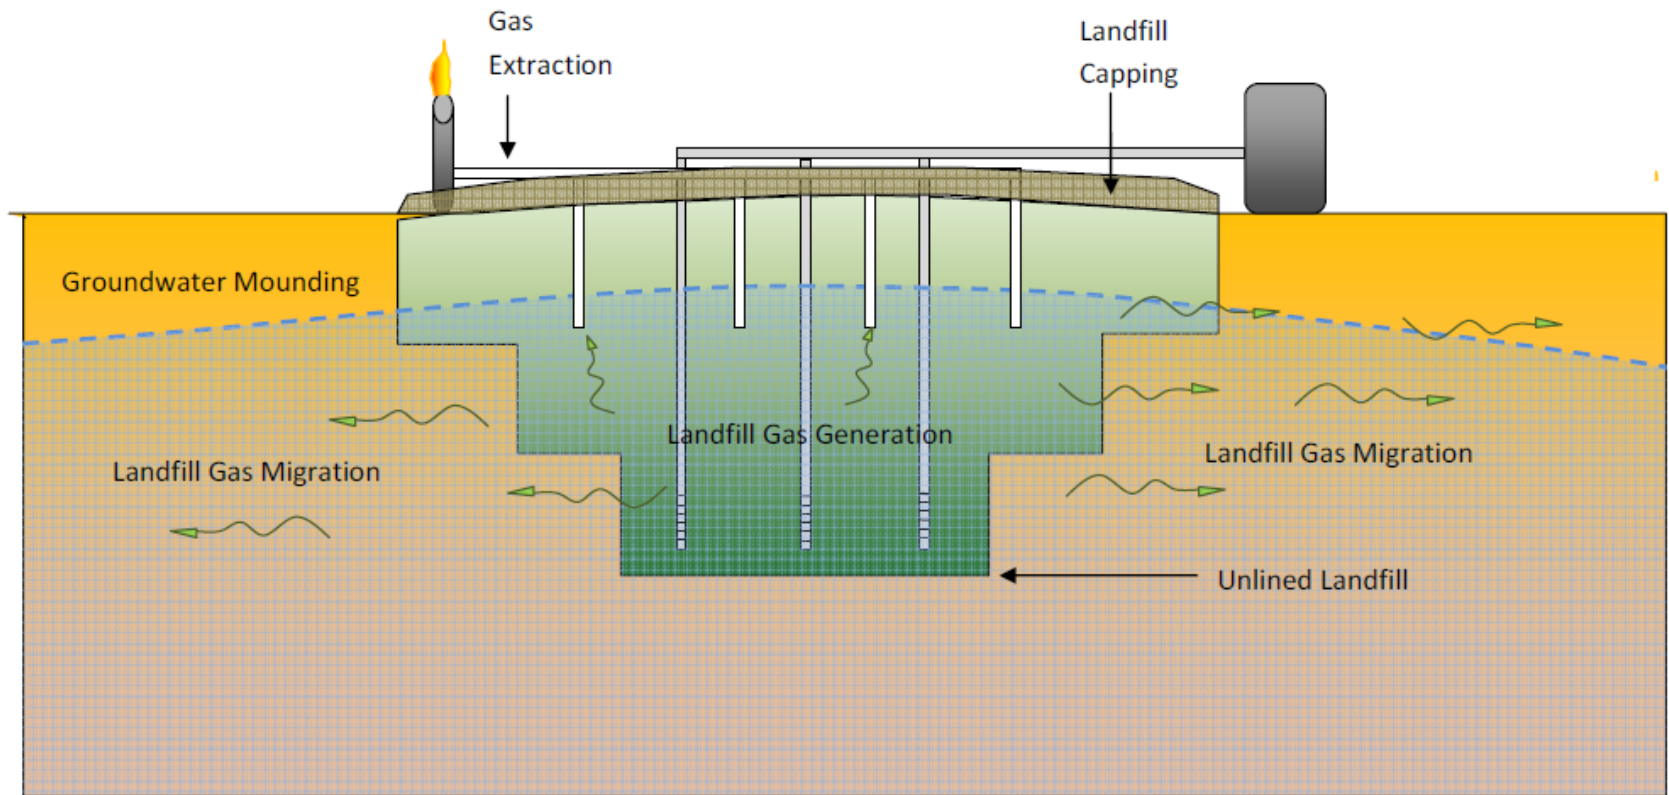
- Final capping of the landfill exacerbated lateral gas migration.

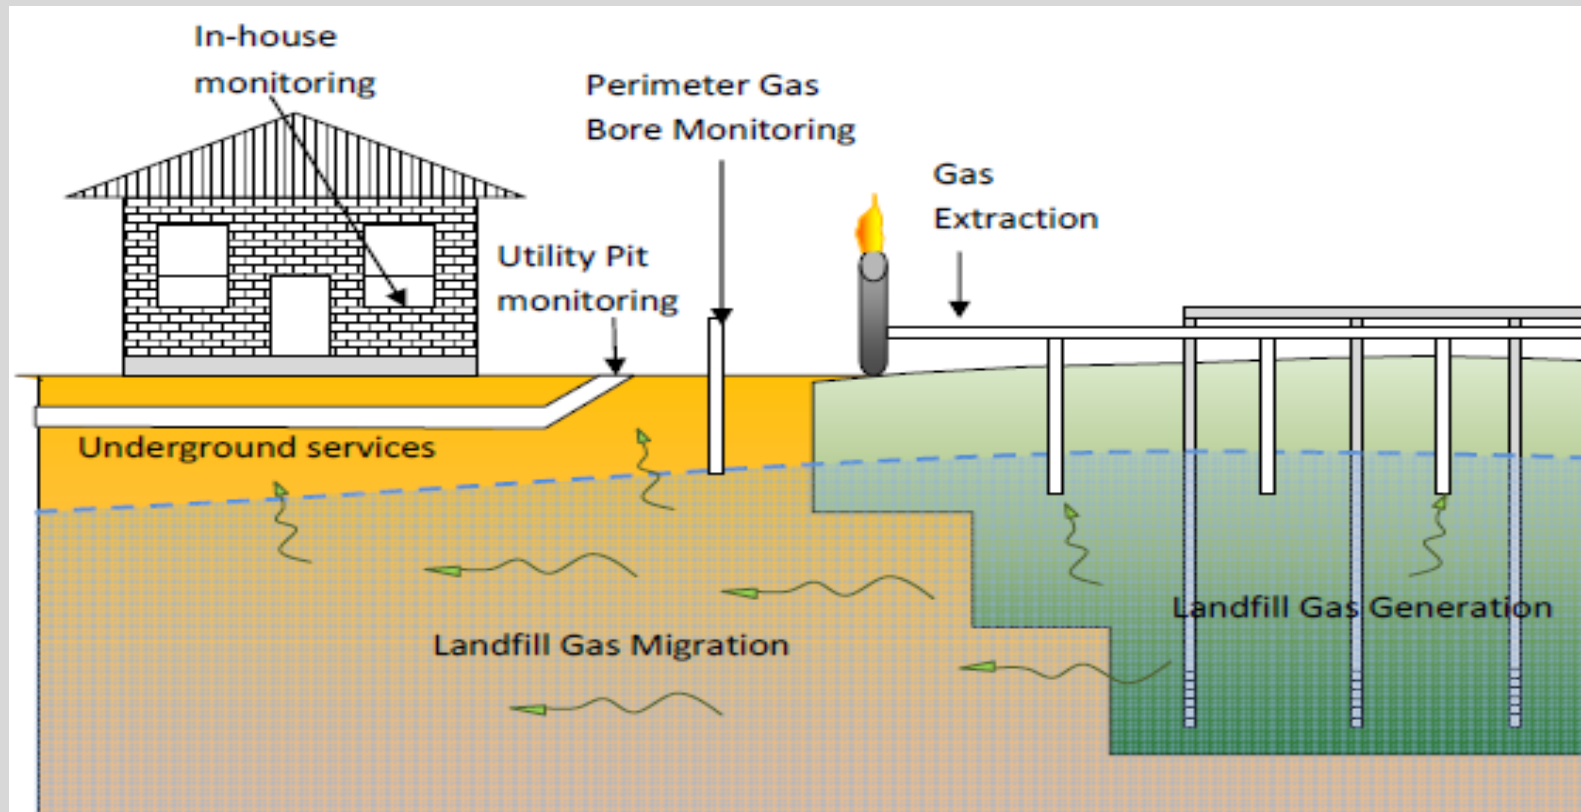
- March 2006 EPA aware that landfill gas was migrating.
- Methane at 63% detected within adjacent house in August 2008, an Emergency Management Plan was lead by the CFA.

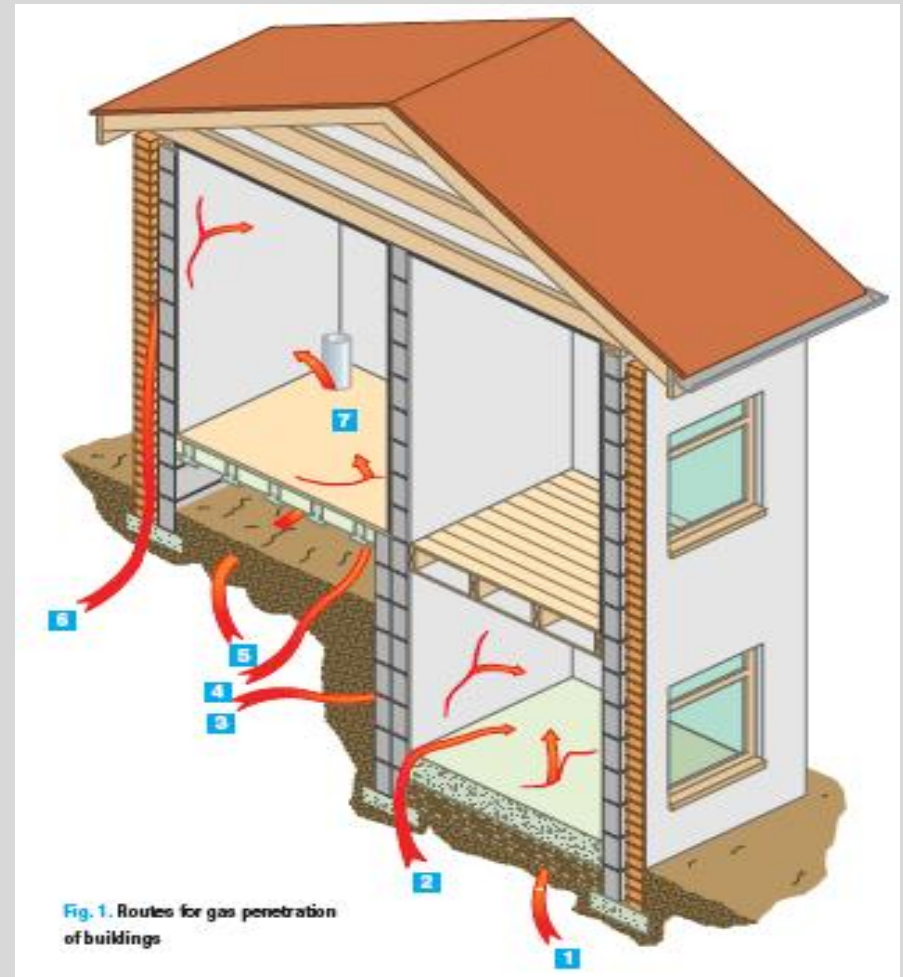
1. Cracks in solid floors
2. Construction joints
3. Cracks in walls below ground level
4. Gaps in suspended concrete or timber floors
5. Gaps around service pipes
6. Cavities in walls
7. Soil and vent pipe
